GUIDELINES for **ESTIMATING** **LOADS** in **TRUCKS**

INTERNAL REVIEW OFFICE

SUBJECT: Internal Review Observation - Katrina LA-RFO 142 - Ceres - Improper Tailgate & Questionable QA Practices

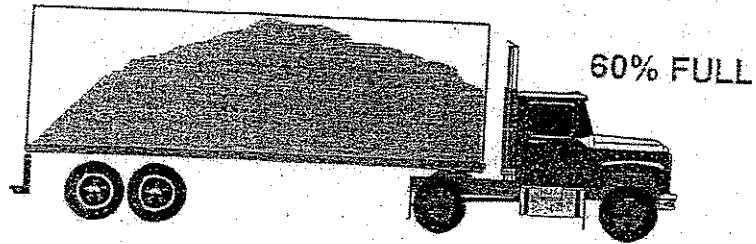
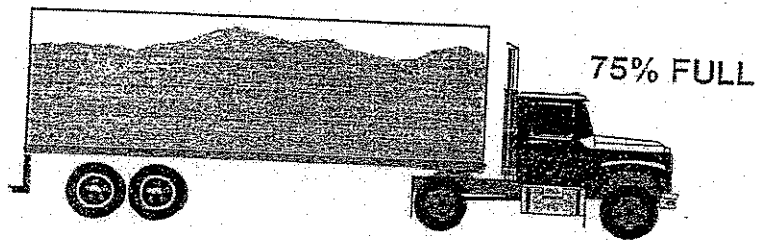
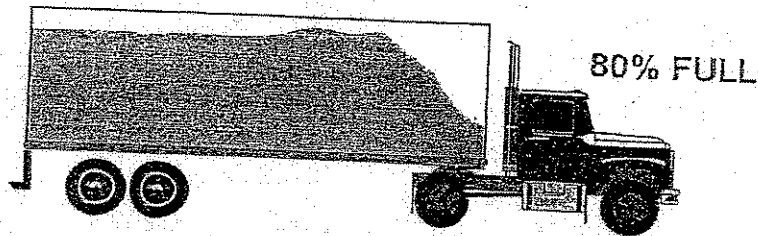
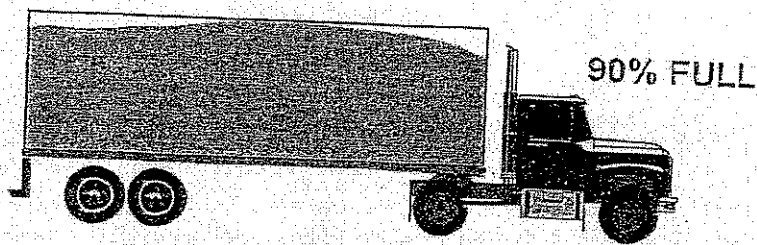
Exhibit L
Attachment A

4. Ensure that the truck is empty when it leaves the disposal site.
5. If there is not a tailgate on the truck, the truck is not full.
6. If the truck is half full, in the Debris Quantity Section of the load ticket note that the load is 50% full. (See Attachment "A" for percentage example of loaded trucks).

7. A truck is 100% full only when the debris is filled completely to the "brim", with no air holes, and the truck is heaped above the sideboards. The truck must have a tailgate that secures the entire back of the truck.

NOTE: It is virtually impossible for a truck to be 100% loaded, because wood debris, tree branches and rubble cannot be placed in a truck with out having air holes/ voids.
